# City of Sumter Historic Preservation Design Review

## HP-21-14, 24 W. Liberty St.

Request: Design Review approval for painting of building

brick façade on W. Liberty St.

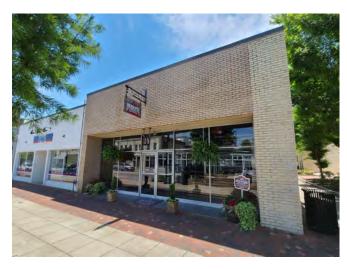
24 W. Liberty St.., shown in the photograph to the right, is a single-story commercial building which received significant interior renovations in 2016 and currently serves as a professional office.

The applicant is proposing to paint the previously unpainted brick exterior portions of the building's front facade.

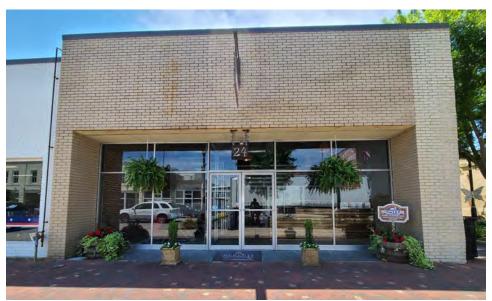
Above: Front (North) Façade of building (Facing W. Liberty St.)

Painting of previously unpainted masonry is not consistent with the City of Sumter Historic Preservation Design Review guidelines, and in this case, there is not a patchwork appearance from extensive replacement or rebuilding, which are exceptions cited in the Design Guidelines.

Most brick is never intended to be painted and painting of brick creates a long-term maintenance need that does not exist with unpainted brick. Moisture trapped within walls and the associated damage it can do, as well as degradation of the paint itself over time both suggest that painting of brick is not an ideal course of action.

With that said, the brick of the building under consideration for this project is not currently considered to be historic or otherwise contributing to the Downtown Design District, Furthermore, an approximately 3 ft strip of the front façade on the portion of the building facing the alley has already been painted, and painting the entire façade would resolve an inconsistent visual appearance and provide some mitigation of the negative consequences of painting unpainted masonry.

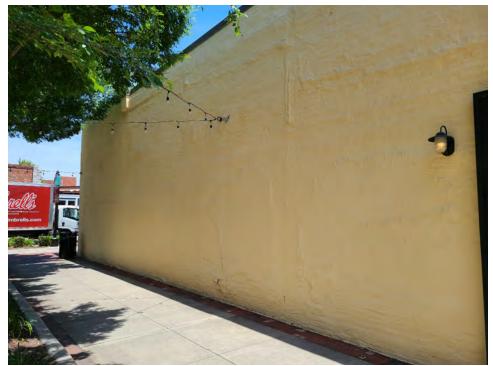
Above: West Façade of building (Facing alley)

The proposed paint color is *Enjoyable Yellow* (SW 6666) for the brick wall. While this color is not included in the City of Sumter Historic Color Palette, the color is compatible with the Design Review Guidelines. This color selection is also an attempt to match the existing alley-facing wall color of the building, which would make the entire building consistent in terms of color.
